# Weight-Optimized Bushingless Connecting Rods: Improving the Tribological Performance of a Gudgeon Pin/Connecting Rod System by Using the Triboconditioning® Process

**Key words:** Triboconditioning, mechanochemical finishing, connecting rod, wear, tribology.

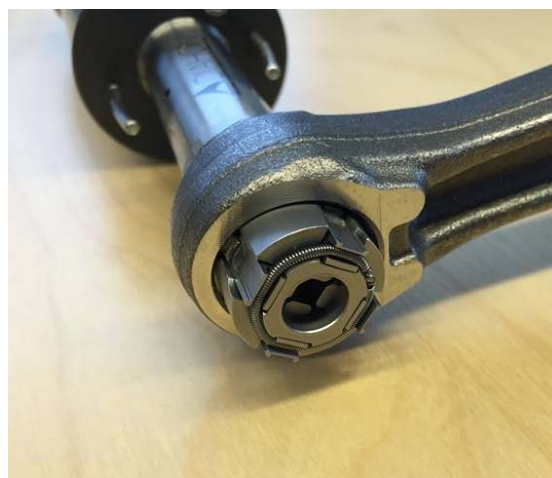
**Fig. 1** Triboconditioning tool used for the treatment of small eye bearing surface.

engine was chosen for this study. The bushing less bearing surface of the small eye was triboconditioned using a 4-slot Diahon coolEX honing tool equipped with cemented tungsten carbide ledges (see Fig. 1). Basic process and tooling design are described elsewhere [5, 6]. The process fluid is pumped into the tool through the spindle creating the expansion of the ledges and pressing them against the small eye surface. The tool spins and simultaneously oscillates in the axial direction to provide a uniform surface finish. The tool and the work piece are continuously flushed with the process fluid which feeds reagents for the chemical reaction, and at the same time, provides lubrication and cooling.

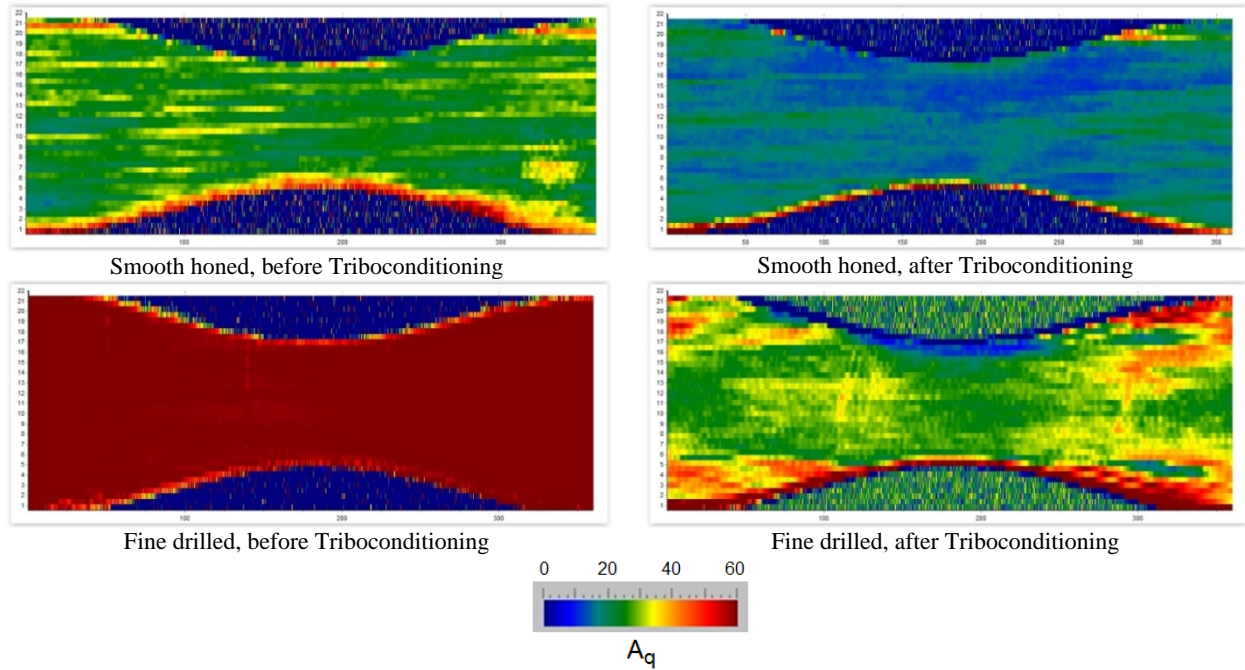
**Fig. 3** Surface mapping of the variance of angular distribution of scattered light ( $A_q$ -value) for the small eye bearing surface. A decrease in the  $A_q$  value reflects plateauing the surface roughness profile due to the Triboconditioning treatment.

In general, the Triboconditioning treatment results in the development of a progressively plateaued roughness profile with reduced  $R_a$ ,  $R_{pk}$ , and increasingly negative skewness with a reduced  $S_{pk}/S_{vk}$  ratio [9]. This fact is evidenced by angle-resolved light scattering measurements, which show a drop in the variance of angular distribution of scattered light ( $A_q$ -value) for triboconditioned surfaces. See Fig. 3.

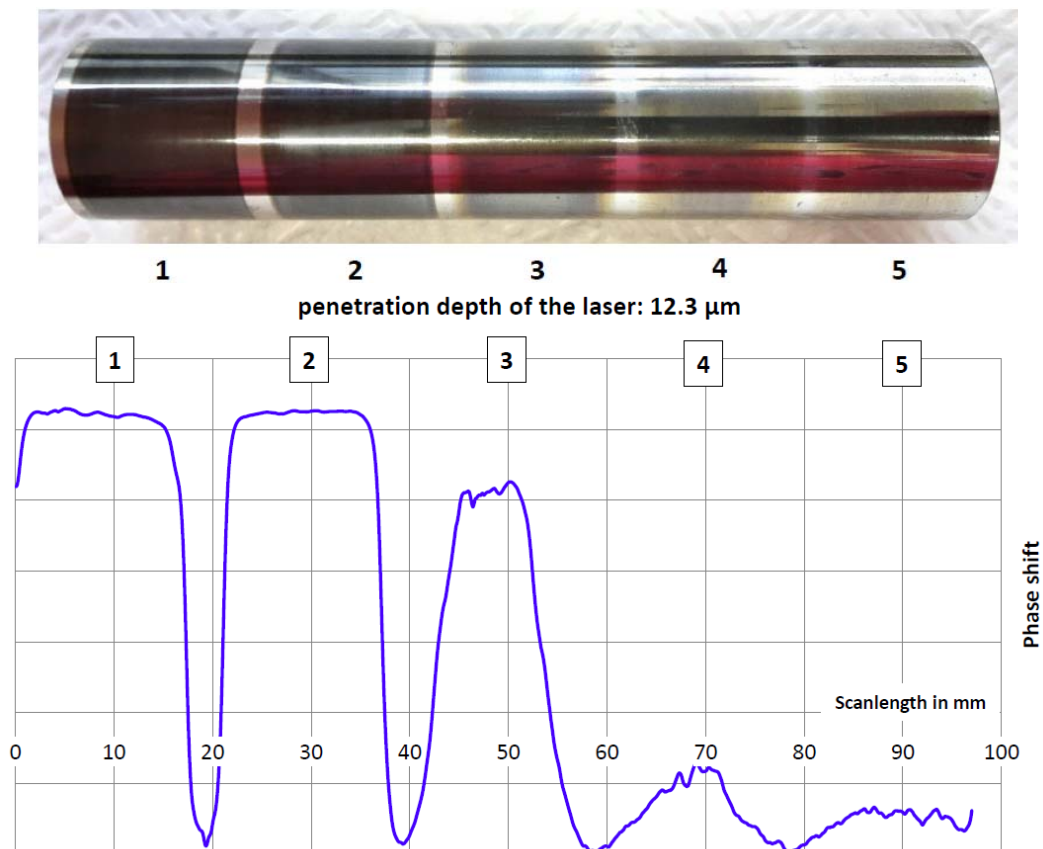
**Fig. 6** Phase shift measured with the photothermal technique for a reference shaft with five different zones triboconditioned under progressively declining loads from 5 to 1 kN. Significant differences between the sections due to microstructure changes in the material are detected at a depth of 11-14  $\mu\text{m}$ .

Photothermal measurements provide indirect indication of the “deformation zone” depth of ca 10  $\mu\text{m}$  (see Fig. 6).

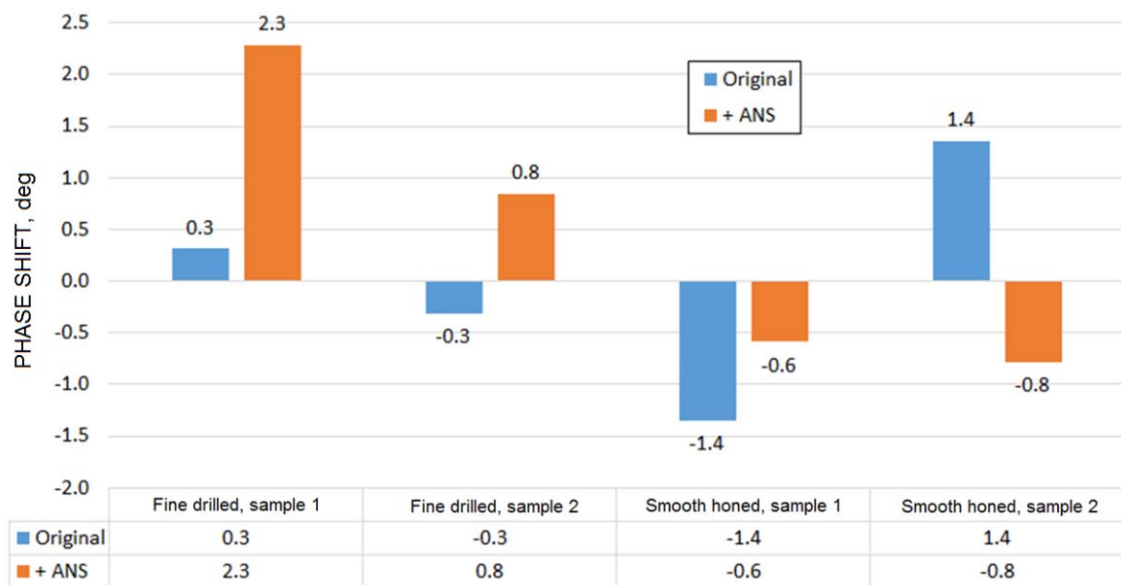
Fig. 9 Average phase shifts detected by the photothermal method at 12.5  $\mu\text{m}$  probing depth.

The corresponding phase shift data are presented in Figs. 8a, 8b, and 9. As can be seen, measurable differences in phase shift between the triboconditioned parts and untreated references, for both fine drilled and smooth honed variants. The differences are more pronounced for smooth honed surfaces.

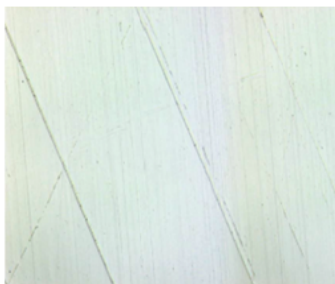
(b)

## SURFACE CONDITION: STEEL CONROD

Steel conrod before test

Steel conrod after test with DLC pin

um	Before	After
R <sub>a</sub>	0.05	0.27
R <sub>pk</sub>	0.06	0.62
R <sub>k</sub>	0.15	0.62
R <sub>vk</sub>	0.09	0.15

Fig. 10 (a-e): Surface condition of the small eye bearing surface before and after the tribotest.

Figs. 10a-10e show the surface condition of different bearing surfaces before and after the tribotest. As can be seen, Triboconditioned small eye bearing surface shows very little wear when tested against a steel pin. In terms of tribological performance, the combination steel pin/triboconditioned small eye turns out be as good as DLC-coated pin/honed small eye, and outperforms all other combinations. This concerns both friction (Fig. 11) and wear (Fig. 12). It is interesting that both bronze bushing and phosphated small eye bearings show abnormally high abrasive wear

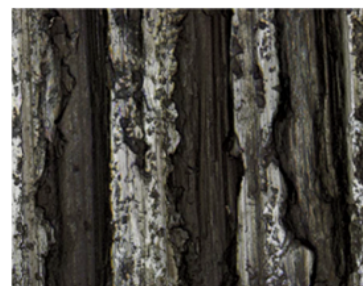
(d)

## SURFACE CONDITION: PHOSPHATED

Before test

After test with steel pin

um	Before	After
R <sub>a</sub>	1.97	12.2
R <sub>pk</sub>	4.38	12.6
R <sub>k</sub>	4.24	25.8
R <sub>vk</sub>	1.47	22.5

levels under the tribotest conditions. This should be taken as a warning sign: these materials are more likely to fail in boosted engines unless the load-bearing surface is properly scaled up, herewith use of lower viscosity crankcase lubricants of ACEA C1, C2, A5/B5, and the forthcoming ACEA C5, API FA-4 and ILSAC GF-6b specifications are associated with a higher failure risk. It should be noted that burnished bearing surface, while showing relatively small wear, has developed micro pitting damage and thus also failed the assessment criteria.

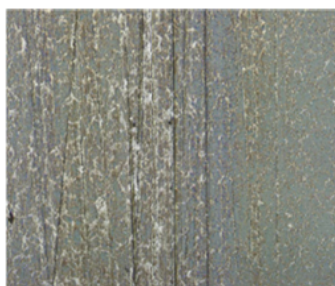
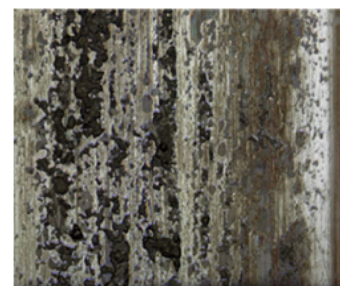
(e)

## SURFACE CONDITION: BURNISHED

Before test

After test with steel pin

um	Before	After
$R_a$	0.12	0.47
$R_{pk}$	0.20	0.56
$R_k$	0.33	0.76
$R_{vk}$	0.17	2.49

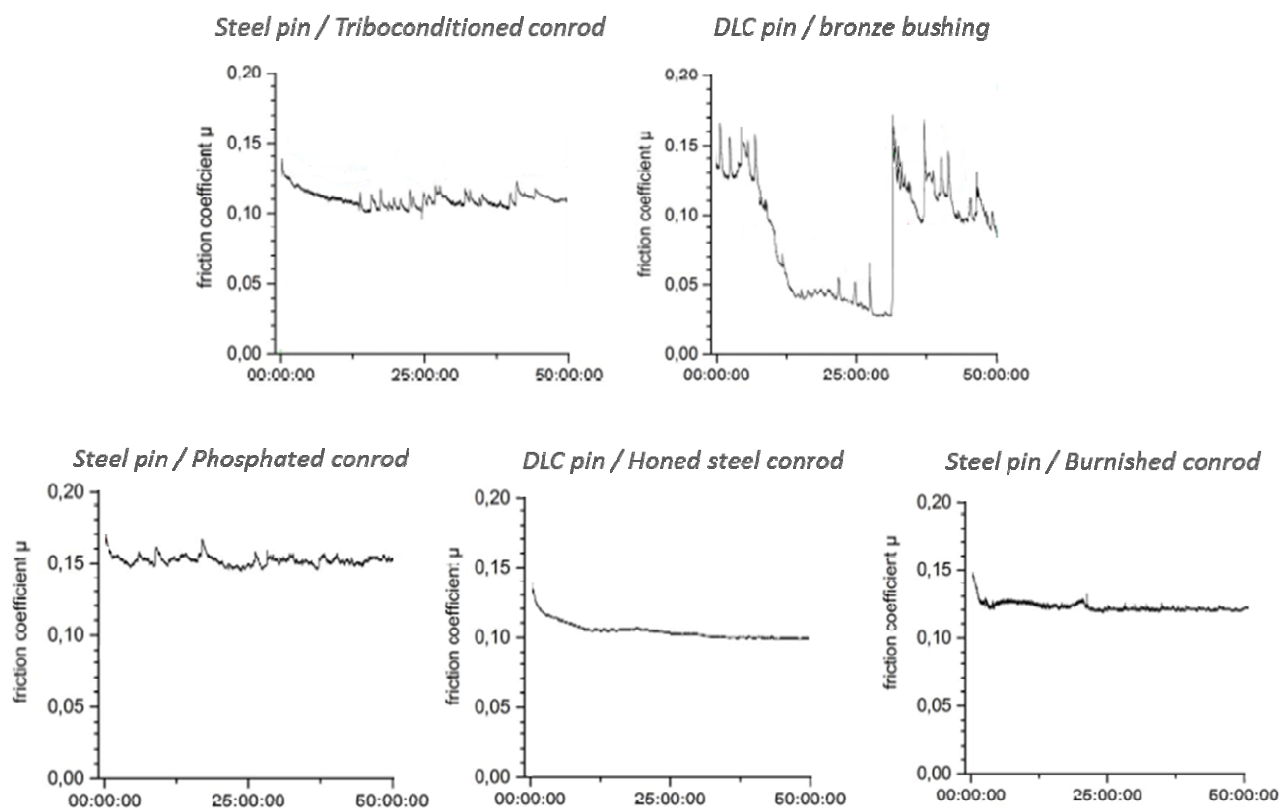
Fig. 11 The coefficient of friction between the pin and the connecting rod for different material combinations.

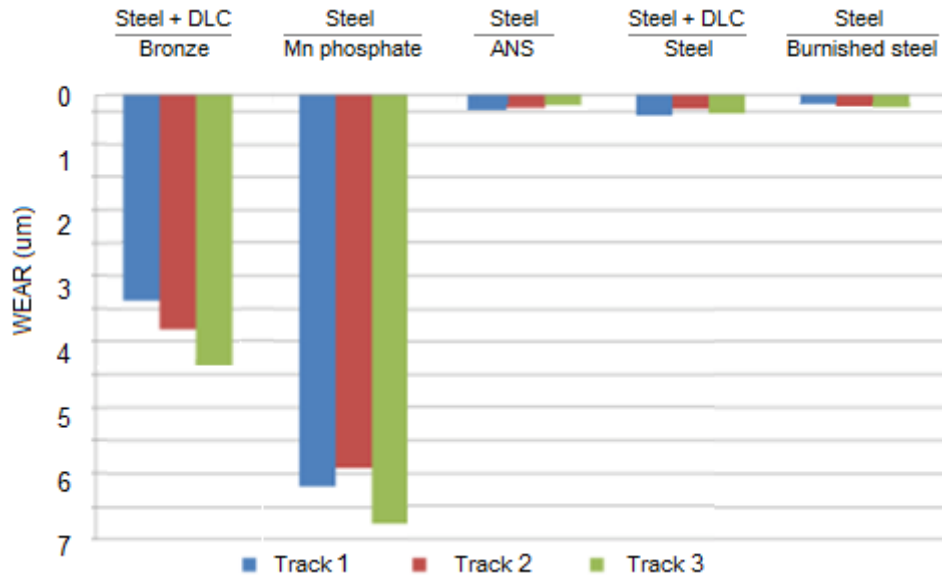
Fig. 12 Average wear depth at the small eye bearing surface after the tribotest.
